**G. WILLIAMS DAM**

**FRANKLIN COUNTY, MISSOURI**

**MO 30574**

**PHASE 1 INSPECTION REPORT  
NATIONAL DAM SAFETY INSPECTION**

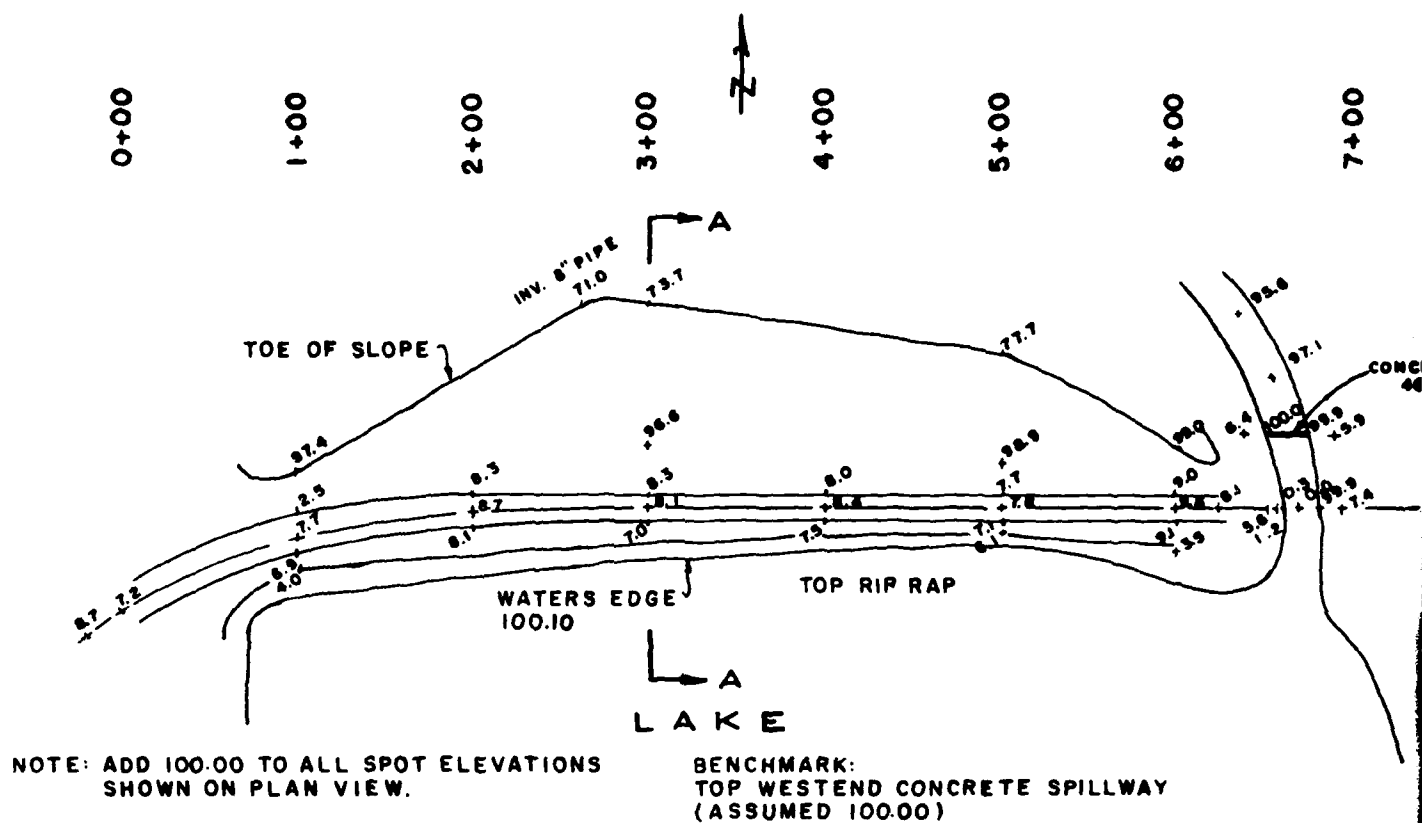
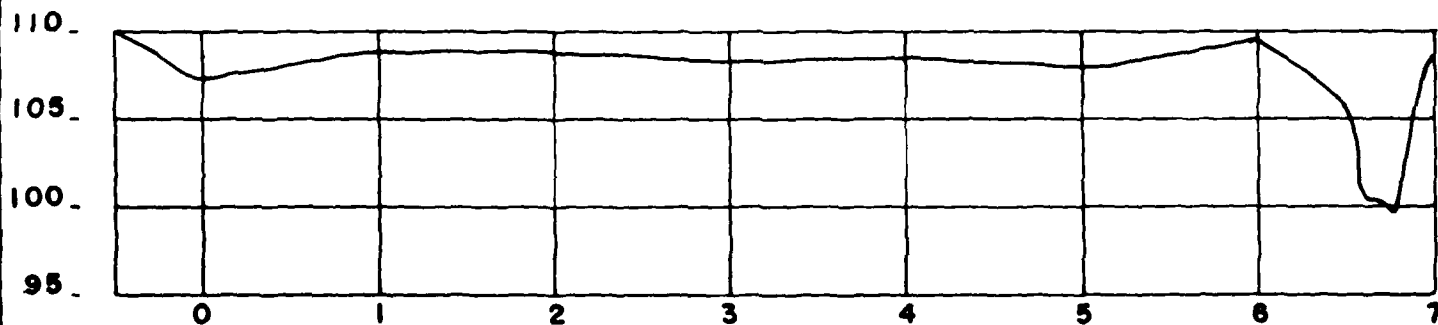
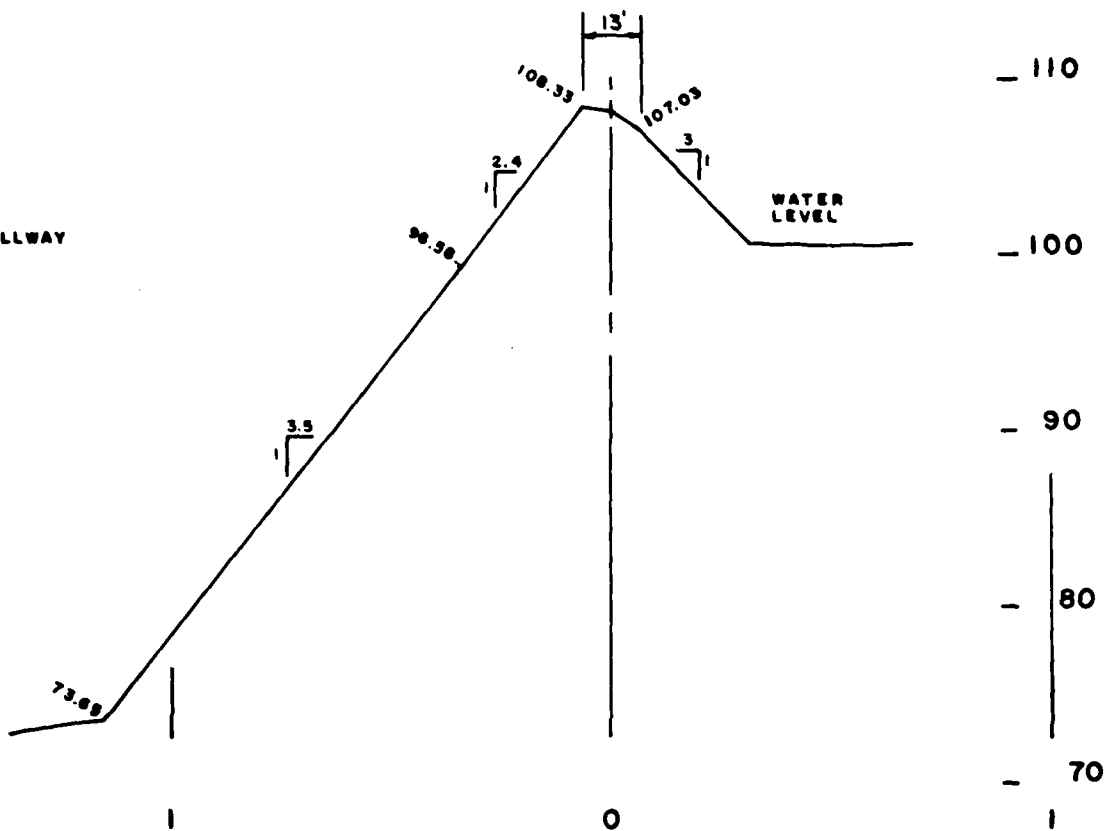
**PLAN & PROFILE**

G. Williams Dam is an earth fill structure approximately 38 ft high and 625 ft long at the crest. The appurtenant works consist of an overflow spillway in the east abutment. The spillway consists of a 24 ft long by approximately 2 ft wide concrete control section (see Photo No. 9 - Appendix D) and a shelved natural rock spillway. An 8 in. diameter steel pipe is provided at station 2+65 to drain the lake. Sheet 3 of Appendix A shows a plan, profile and typical section of the embankment.

Pertinent data about the dam, appurtenant works, and reservoir are presented in the following paragraphs. Sheet 3 of Appendix A presents a plan, profile and typical section of the embankment.

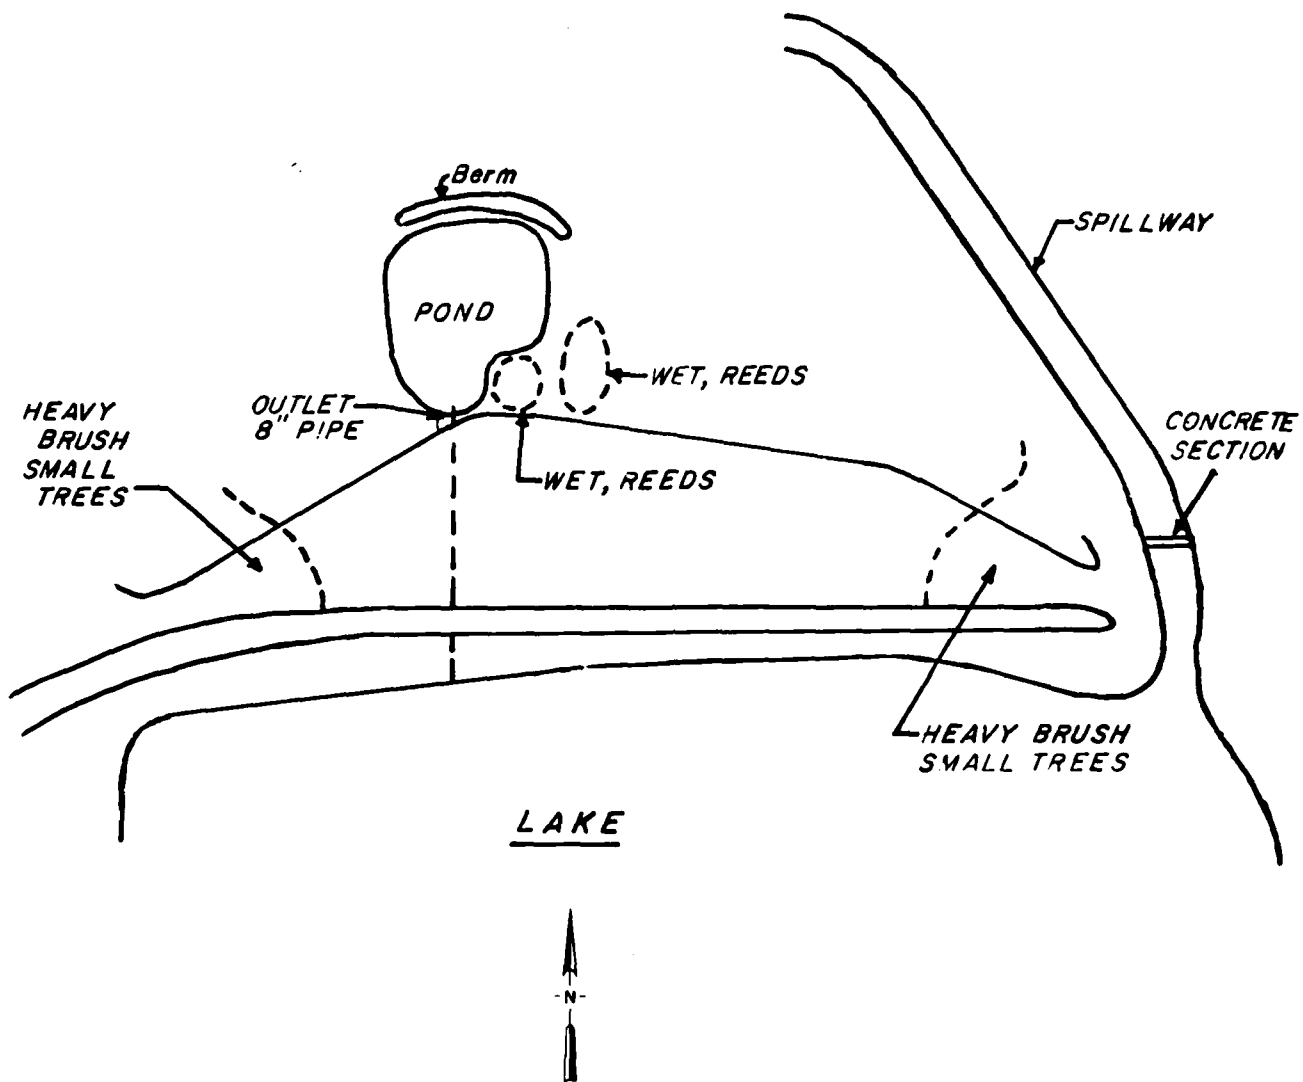
Wet areas with reeds and cattails were noted at the toe of the dam and in the floodplain downstream as shown on Sheet 4 of Appendix A. These areas could be the result of back-up of the small pond located at the base of the dam (pond used to water cattle) and poor drainage. It is also possible that some leakage could be occurring under the dam in the area of the old streambed.

- (4) Erosional areas at dam-abutment contacts should be corrected and maintained.
- (5) The possible seepage area at the downstream toe should be evaluated by an engineer experienced in the design of dams.
- (6) The concrete control section should be inspected periodically and stabilized if necessary, even though its failure would probably not cause a catastrophic failure of the dam.
- (7) A detailed inspection of the dam should be made periodically by an engineer experienced in the design and construction of dams.
- (8) The valve on the drawdown pipe should be opened periodically to insure that it is operable.

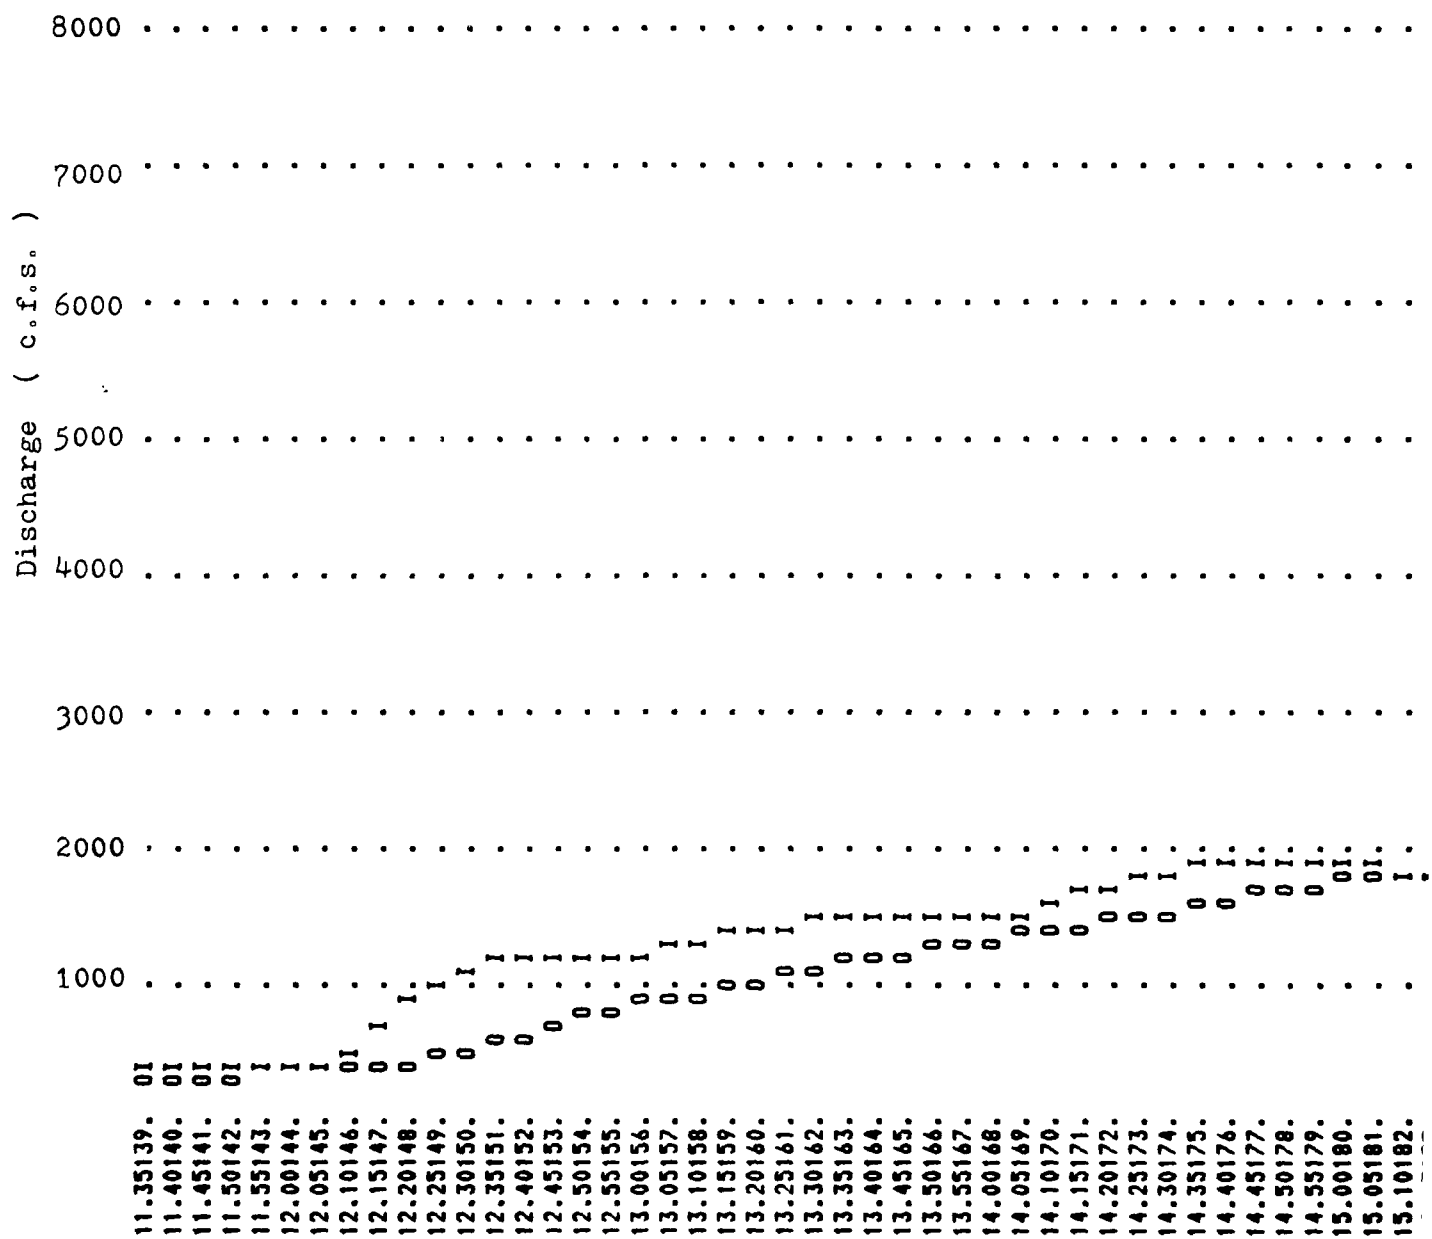
INFLOW - OUTFLOW  
HYDROGRAPH  
FOR 100% P. M. F.

The routing of the PMF through the spillway and dam indicates that the dam will be overtopped by 1.79 ft at elevation 683.79. The duration of the overtopping will be 1.33 hours, and the maximum outflow will be 7438 cfs. The routing of 50 percent of the PMF through the spillway and dam indicates that the dam will be overtopped by 0.45 ft at elevation 682.43. The duration of the overtopping will be 0.42 hours, and the maximum outflow will be 2713 cfs. The maximum discharge capacity of the spillway is 1973 cfs. Overtopping of an earthen embankment could cause serious erosion and could possibly lead to failure of the structure. The residual silty clays which appear to make up the dam are generally not considered to be highly erodible materials.

- (1) Spillway size and/or height of dam should be increased to pass the PMF. In either case, the spillway should be protected to prevent erosion.
- (2) Seepage and stability analyses comparable to the requirements of the recommended guidelines should be performed by an engineer experienced in the construction of dams.
- (3) Brush and tree growth should be removed from the dam and from the approach to the spillway. This should be done under the guidance of a professional engineer experienced in the design and construction of dams. Indiscriminate clearing methods could jeopardize the safety of the dam. It would also appear advisable to provide some erosion protection in the spillway approach area on the west side (embankment side).
